Western Australia

Plumbing Issues Update

13 October 2023

Fletcher Building Limited

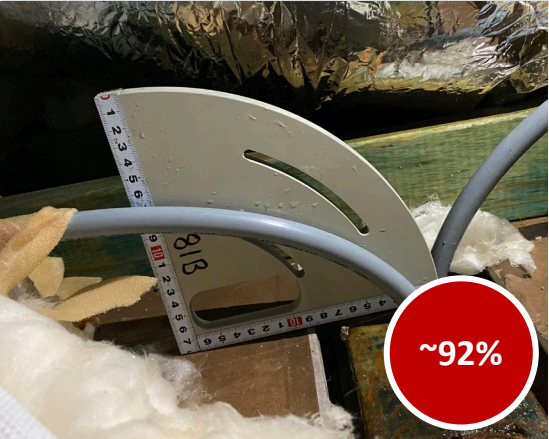
1 OVER-BENDING

The Iplex Pro-fit Technical Guide states that the minimum bending radius be 10 times the outside diameter of the pipe. If this is not possible an IPLEX Pro-fit® elbow should be used.

Pipe overbent

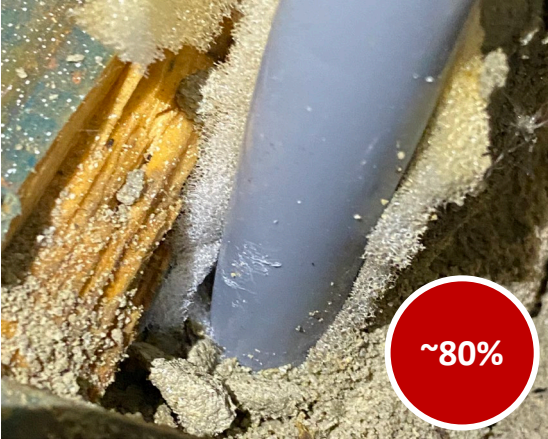
2 INADEQUATE MOVEMENT

Iplex installation instructions state that care must be taken during install to allow for potential thermal movement of the pipe. Additionally, Australian standards require pipes to be supported with adequate brackets, clips or hangers with defined maximum spacings.

Pipe fixed in the wall through rigid mortar

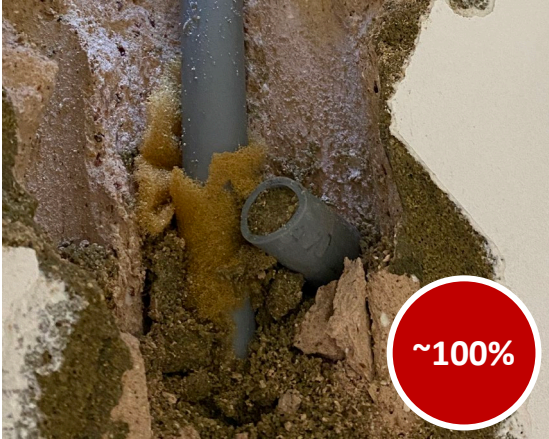
3 POOR LAGGING

Plumbing standard AS/NZS 3500.1&4 and Iplex installation instructions state that pipes in chases shall be continuously wrapped with an impermeable flexible material.

Lagging not impermeable (and at times non-existent)

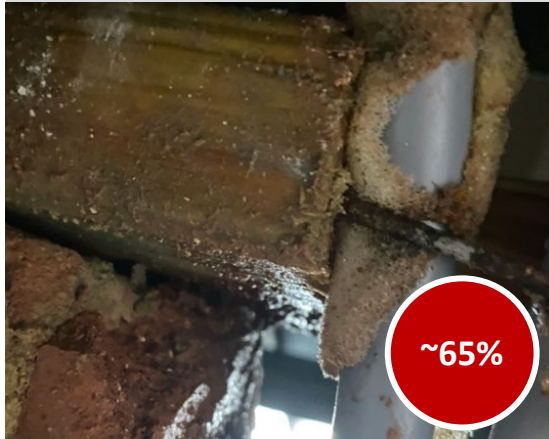
4 DAMAGE / WORKMANSHIP

Plumbing standards AS/NZS 3500.1&4 and Iplex installation instructions note that care should be taken to ensure pipes are not damaged during normal building activities.

Pipe bend across metal nail and kinked, resulting in a stress point

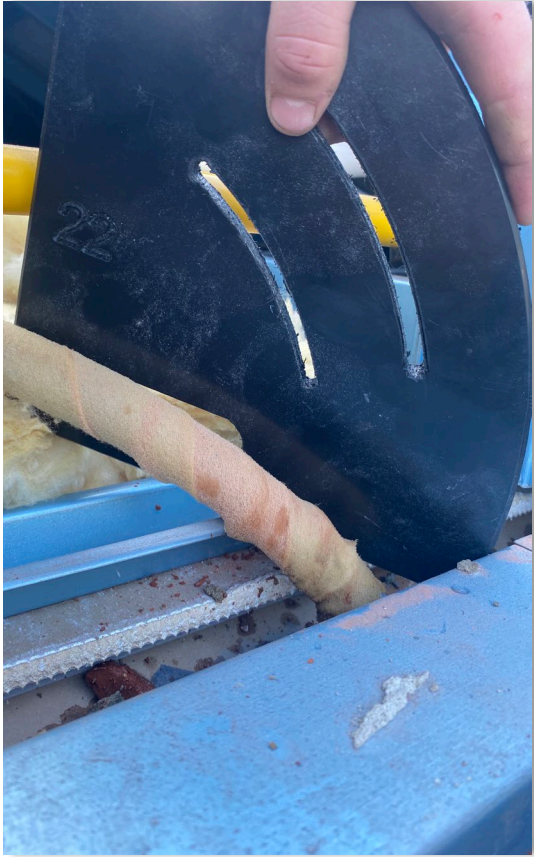
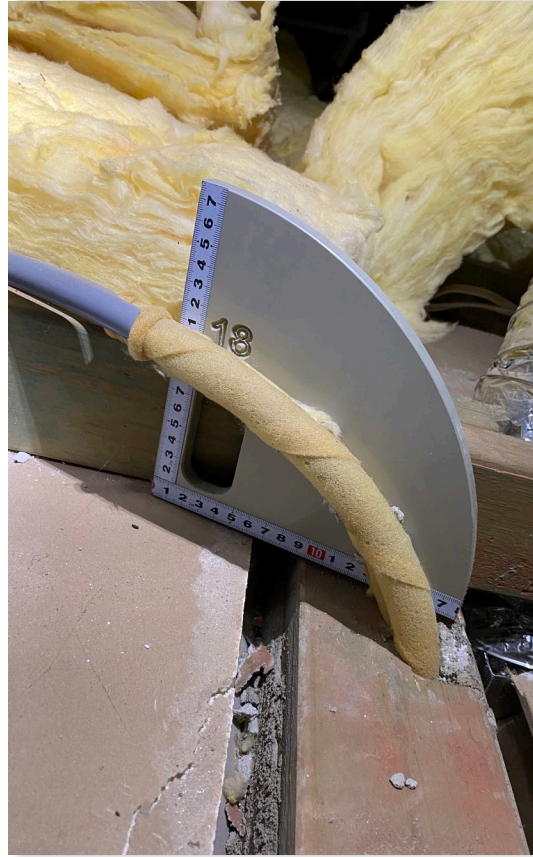
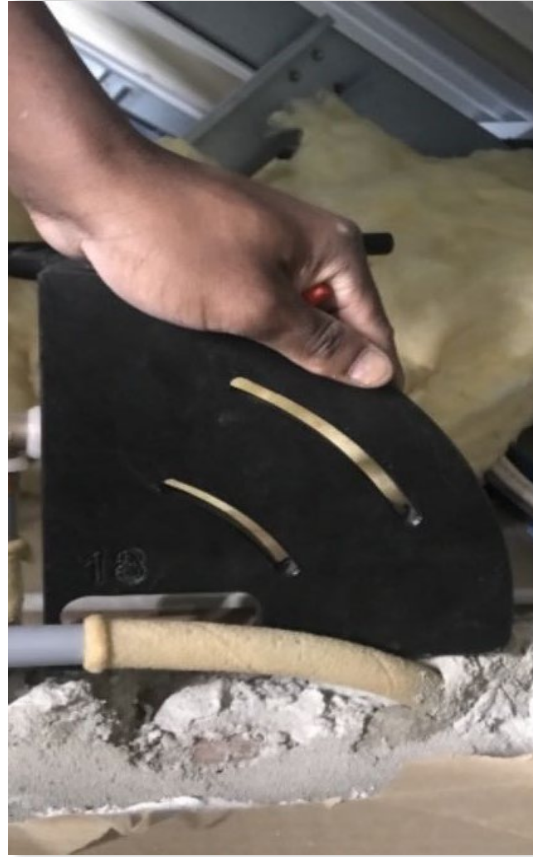
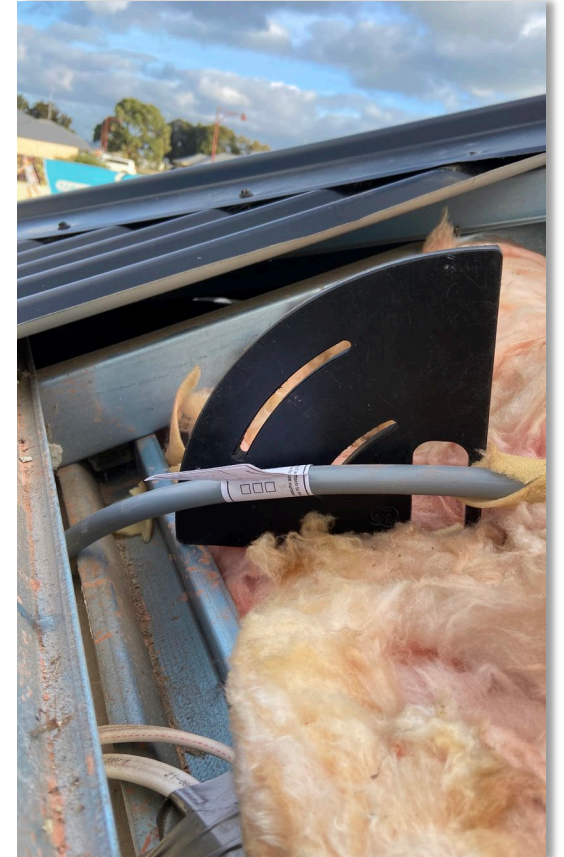
~92% of homes we have inspected / repaired have had non-compliant radial bends

Minimum bending radius must be 10 times the outside diameter of the pipe. All of the pipes shown here have been over-bent

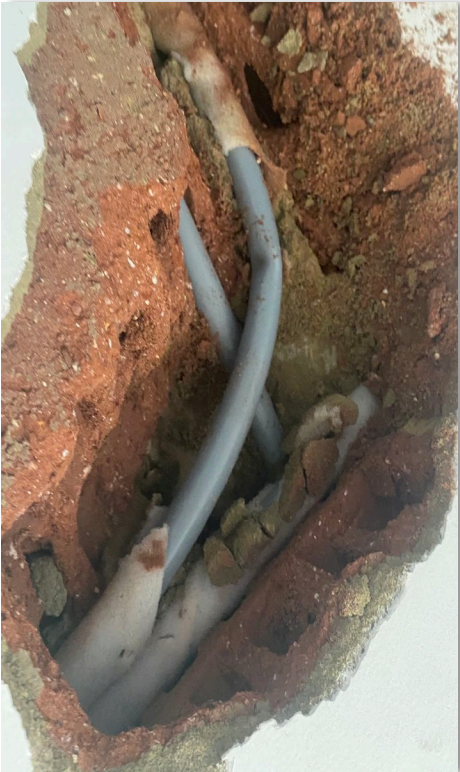
Kinked or damaged pipes, pipes overlapping; tight bend on back pipe

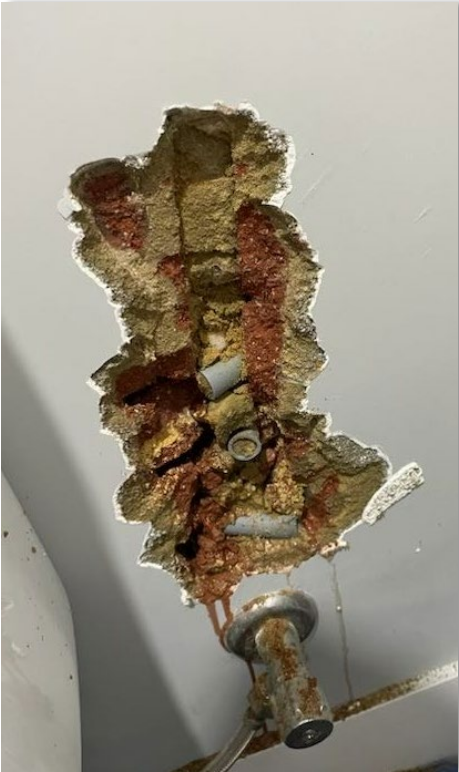
Pinch/pressure point caused by pegging creating localised high stresses

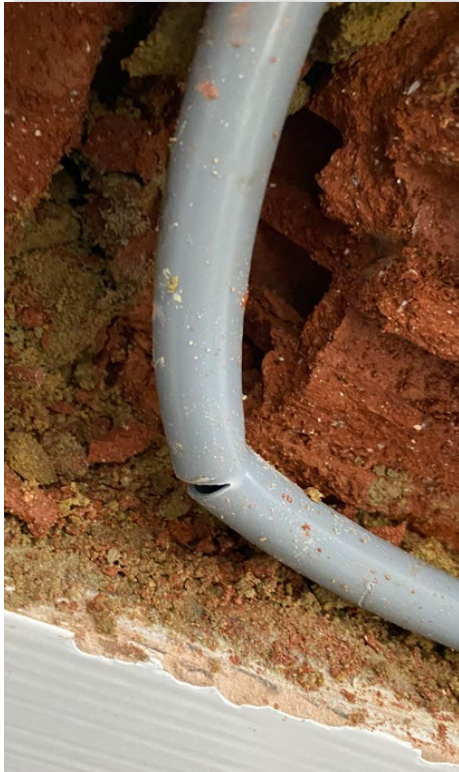
Kinking or damaged pipe not replaced per guidelines

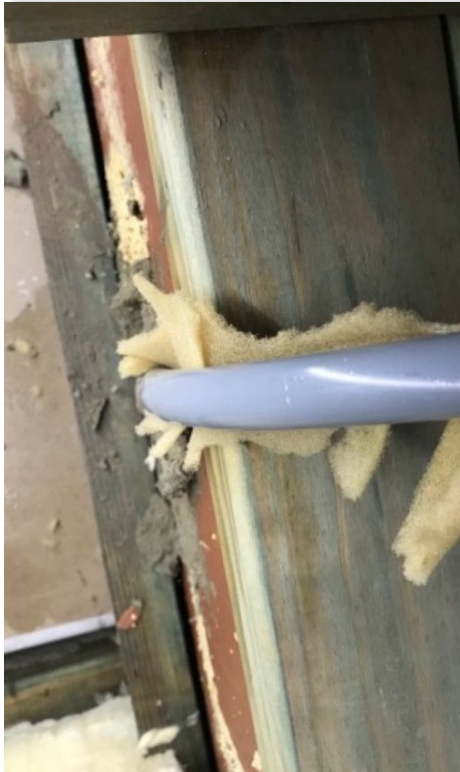
Pulled hard against timber not allowing for lineal thermal expansion per guidelines

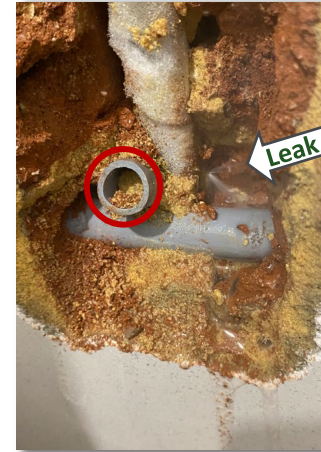
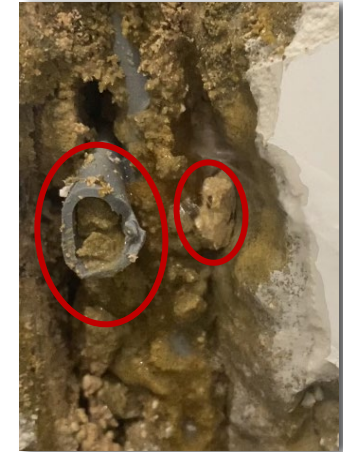
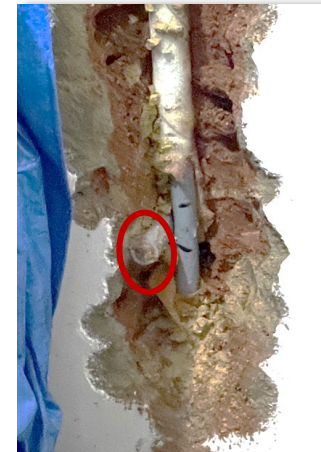
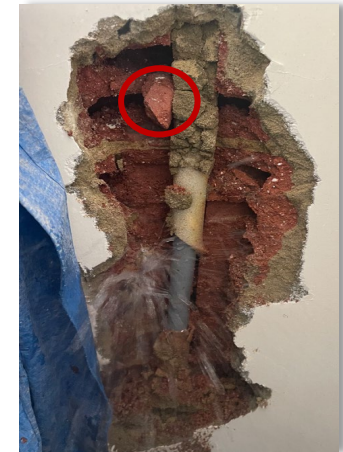
'Pegging' is a process that uses a fixed object to hold the pipe during installation which that installation instructions require to be removed prior to the system being put into service.

Inadequate movement and damage to pipe caused by pegging left in chase

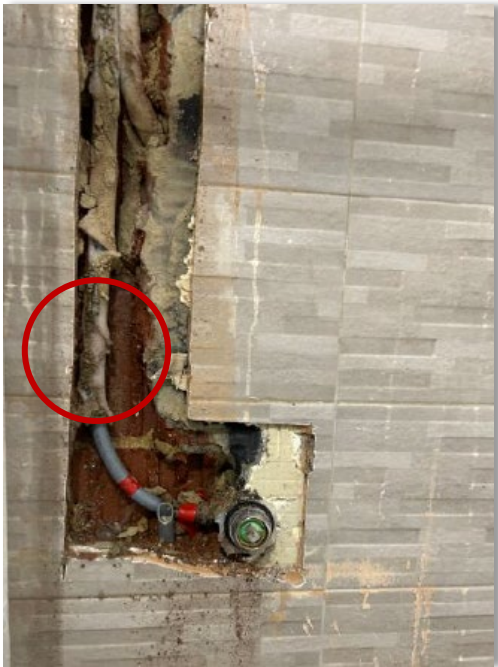
Lagging material (wrapping around pipe), which appears to be permeable – this is not compliant with the relevant Australian Standard

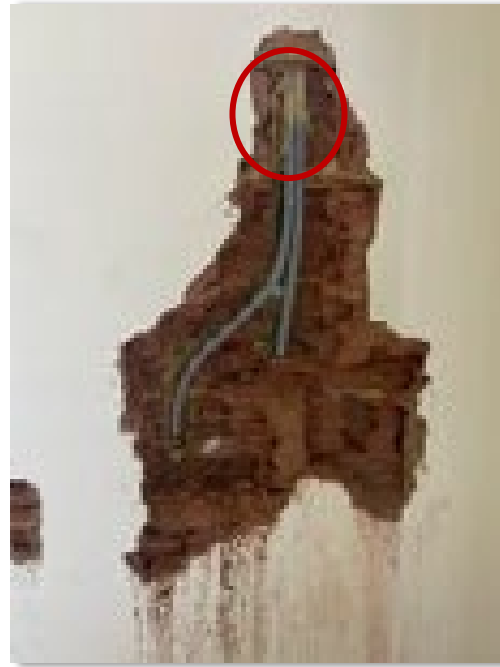
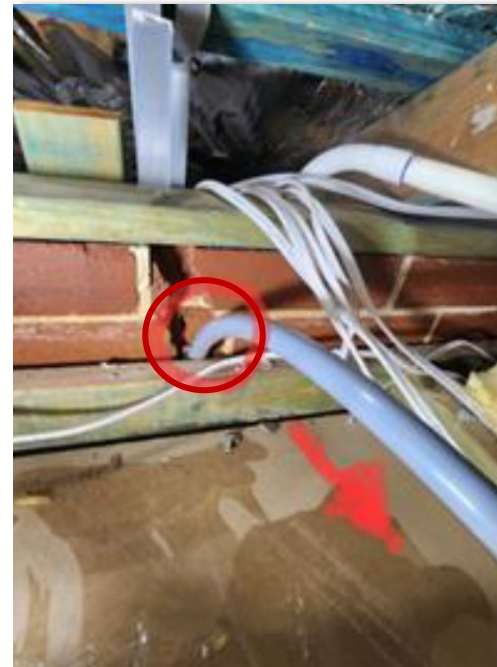
The bend of these pipes are likely to be outside of Iplex Pro-fit instructions (too tight), placing stress on the pipes

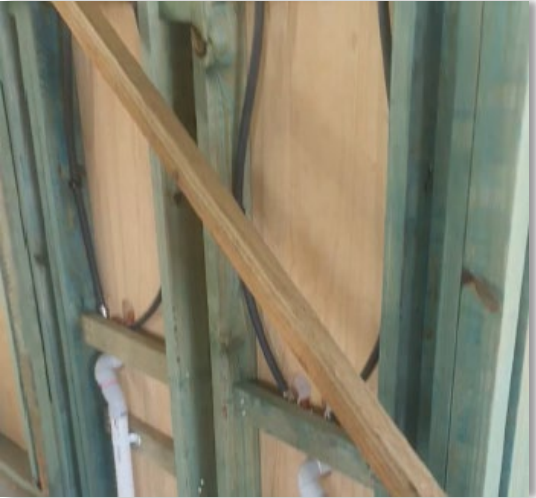
Timber frames allow the pipe to be installed within the open space of the wall cavity, allowing for **adequate movement due to thermal expansion and contraction**, while still being supported with sufficient clipping.

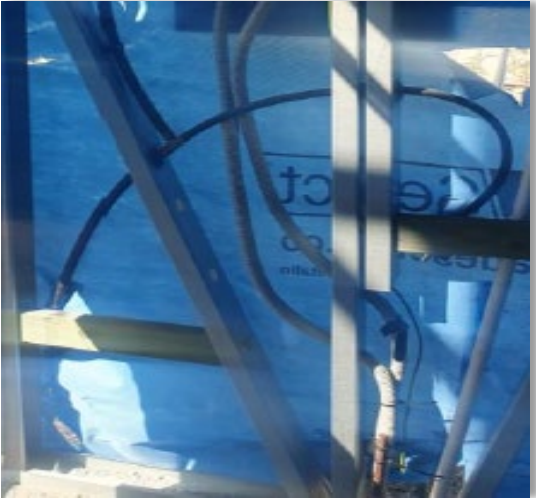
While tight bends are still visible in these images, the pipes are able to **freely expand and contract within the open wall cavity** during expected regular changes in the pipe's temperature and pressure (e.g. water hammer).

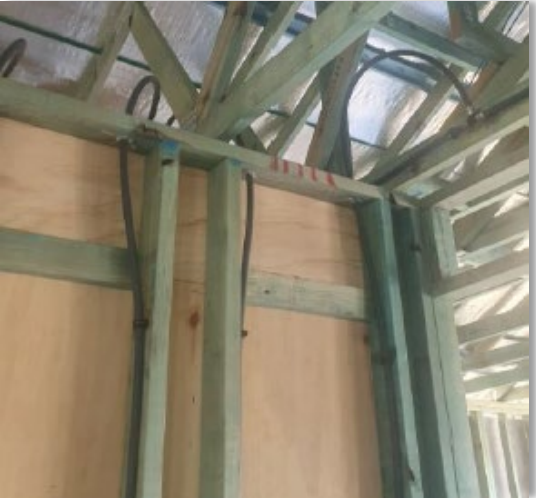
Holes cored in the top plate allow for **adequate movement** of the pipe due to thermal expansion and contraction without being held tightly by a mortar fill.
