Western Australia

Plumbing Issues Update

13 October 2023

Fletcher Building Limited

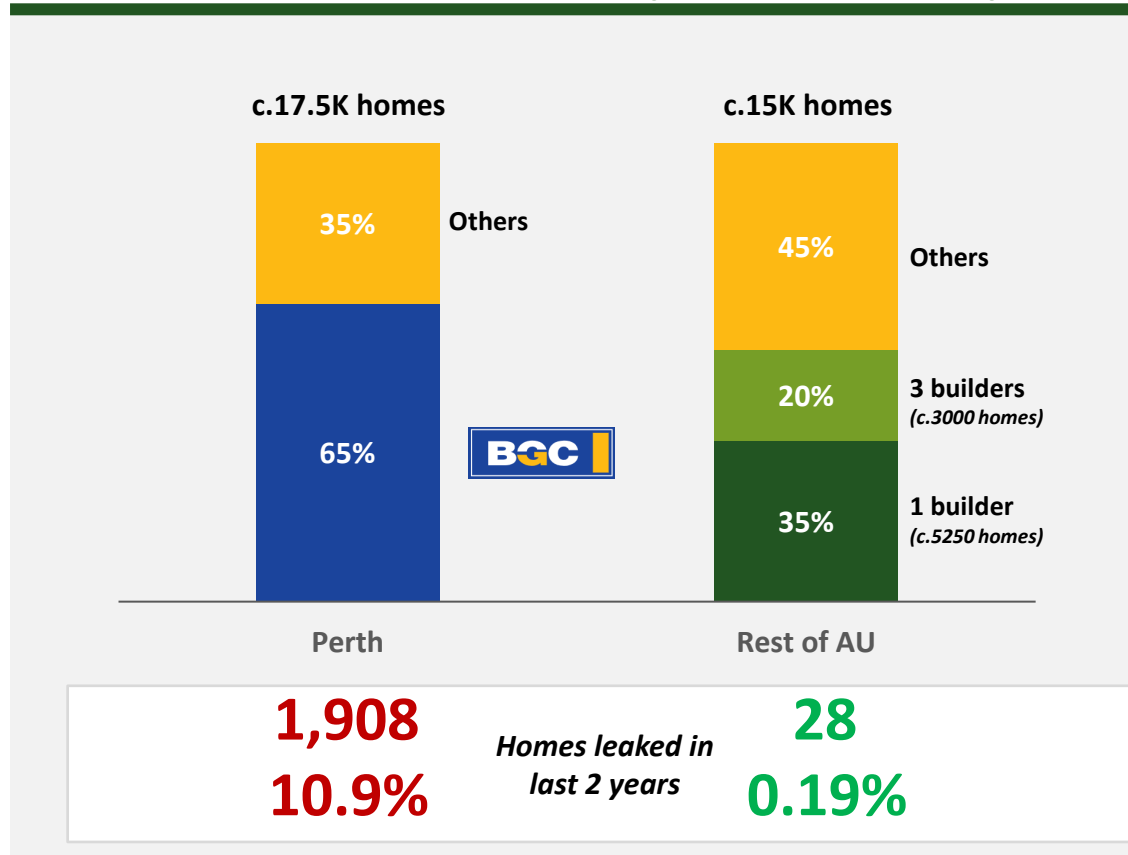
Homes built with Pro-Fit (mid 2017 – 2022)

- ➔ Similar volumes of Pro-Fit sold in Perth and rest of AU from 2017-2022
- ➔ Iplex has reached out to all our merchants and major plumbers / builders on the East Coast – they report no abnormal leak rates

- ➔ **Over the last 2 years, we have been made aware of only 28 homes in the rest of AU that have been impacted by plumbing failures involving Iplex pipe in homes built since mid-2017.**

- ➔ **Of these 28 homes, only 1 was determined to have a manufacturing defect with 8 yet to be determined/tested**
- ➔ BGC is misrepresenting the role of the failures it refers to in Victoria. These are known to Iplex and captured in our data. All tests completed on samples provided so far from that builder have not found any manufacturing fault.

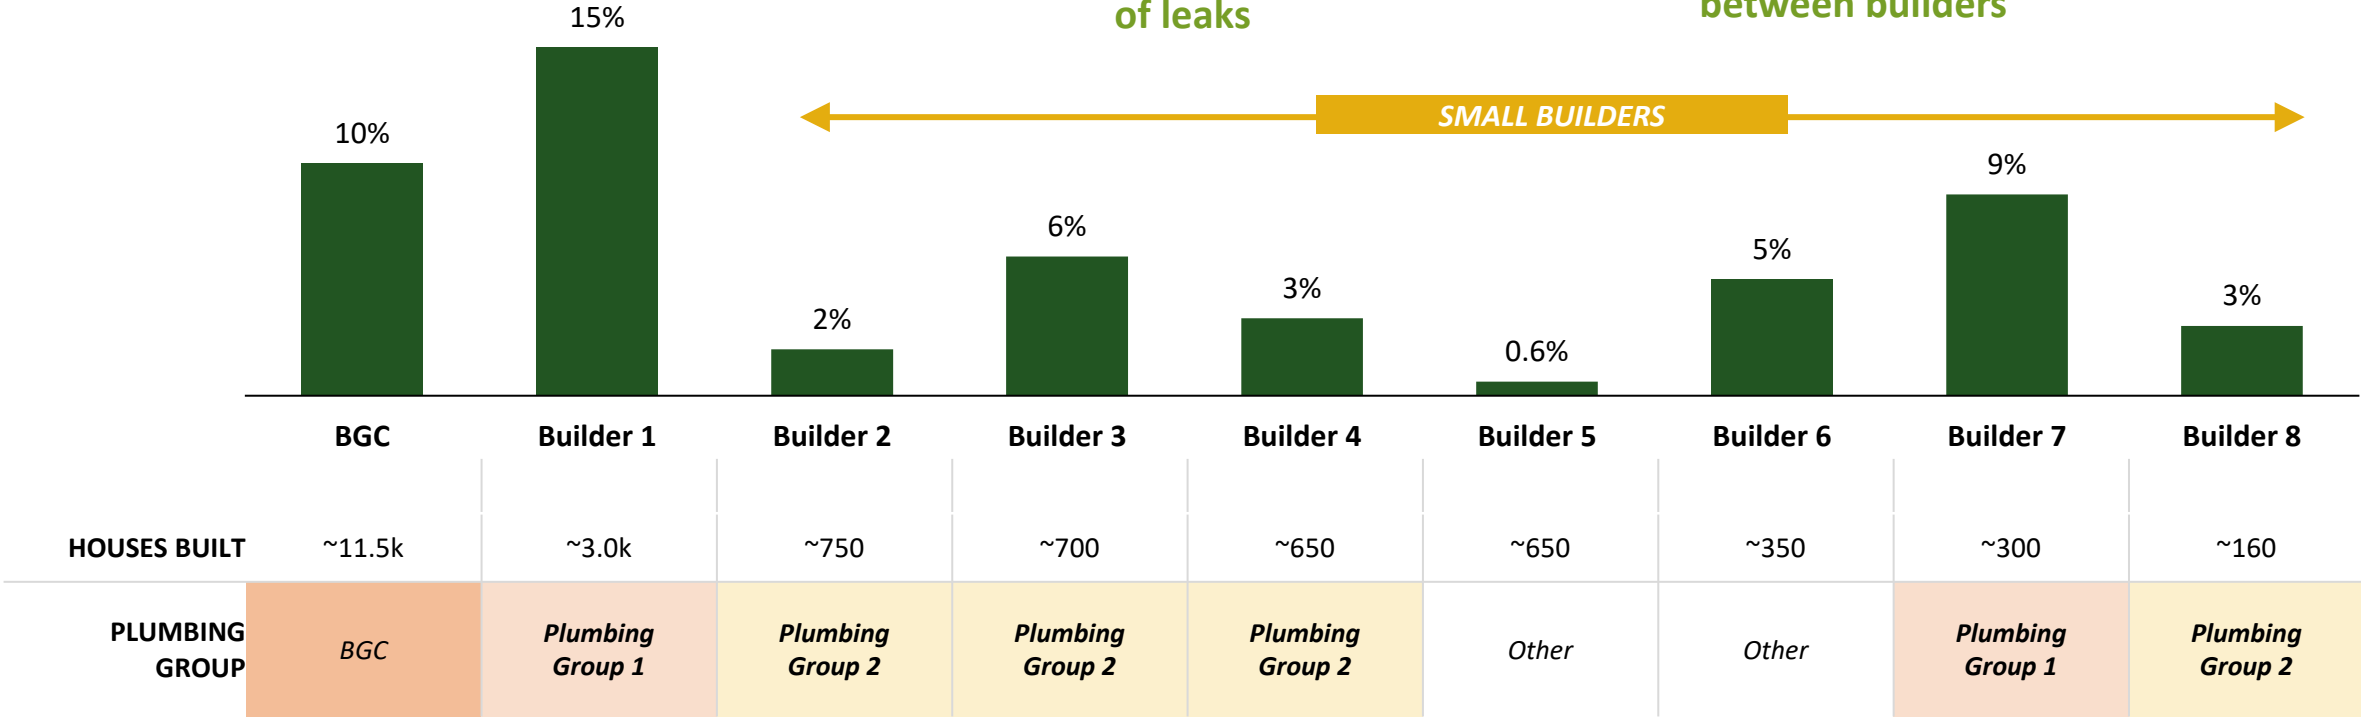
The abnormal plumbing failure rates are only occurring in the Perth area but rates of failure are very different across participants

Plumbing failure rates
 (% of plumbing failures¹ / homes built between 2017-22)

1 BGC and two plumbing groups account for **94%** of leaks

2 Significantly different plumbing failure rates between builders

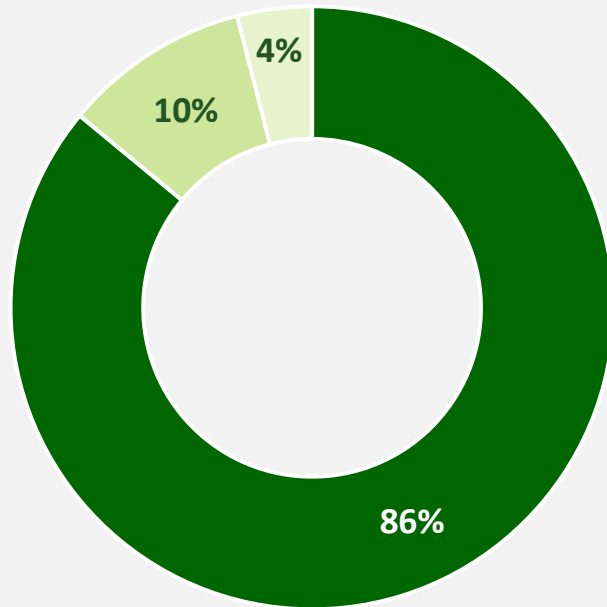
96% of homes have at least 1 installation failure. 86% have multiple installation failures

Plumbing installation failings seen across home inspections

■ 2+ plumbing installation failures ■ 1 plumbing installation failure ■ Other issues

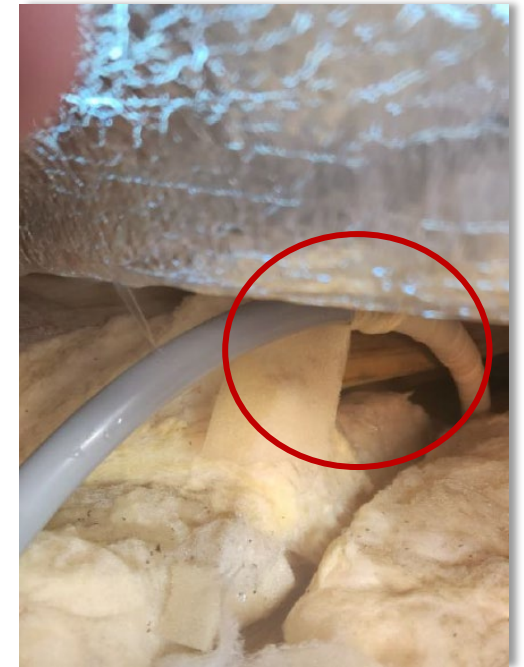
The bend of these pipes are likely to be outside of Iplex Pro-fit instructions (too tight), placing stress on the pipes

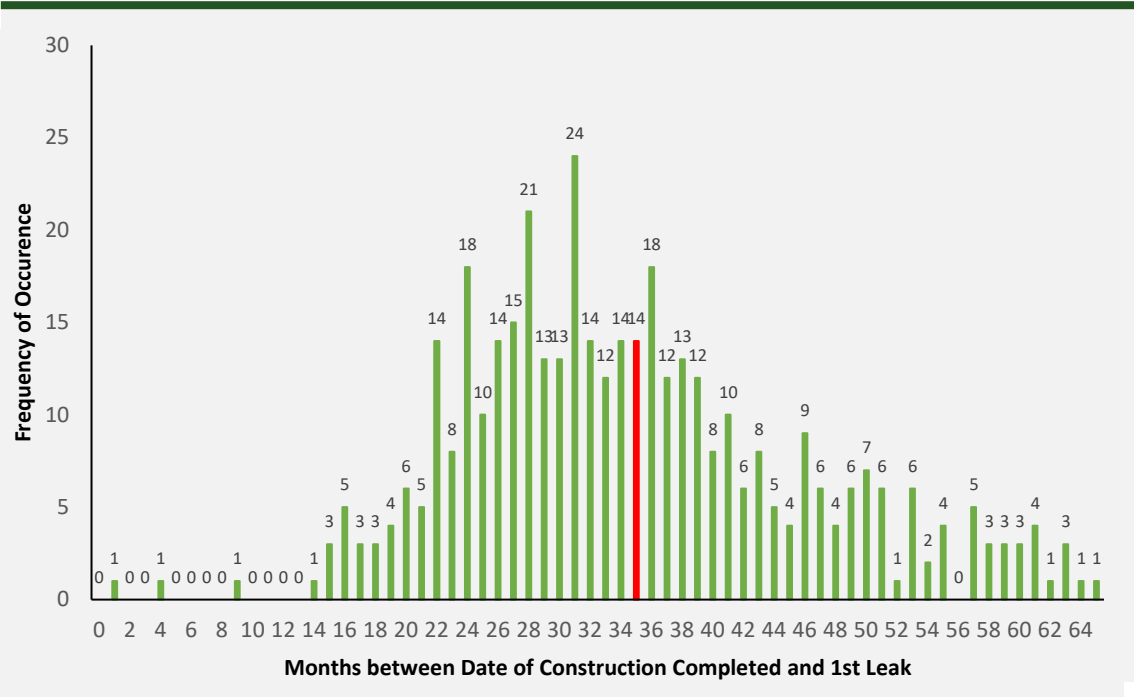
Time from construction completed to 1st leak (in months)

- Graph shows the average period of time from house build date to a home's first leak is 35 months
- Houses are unlikely to leak after 5 years have past the construction date

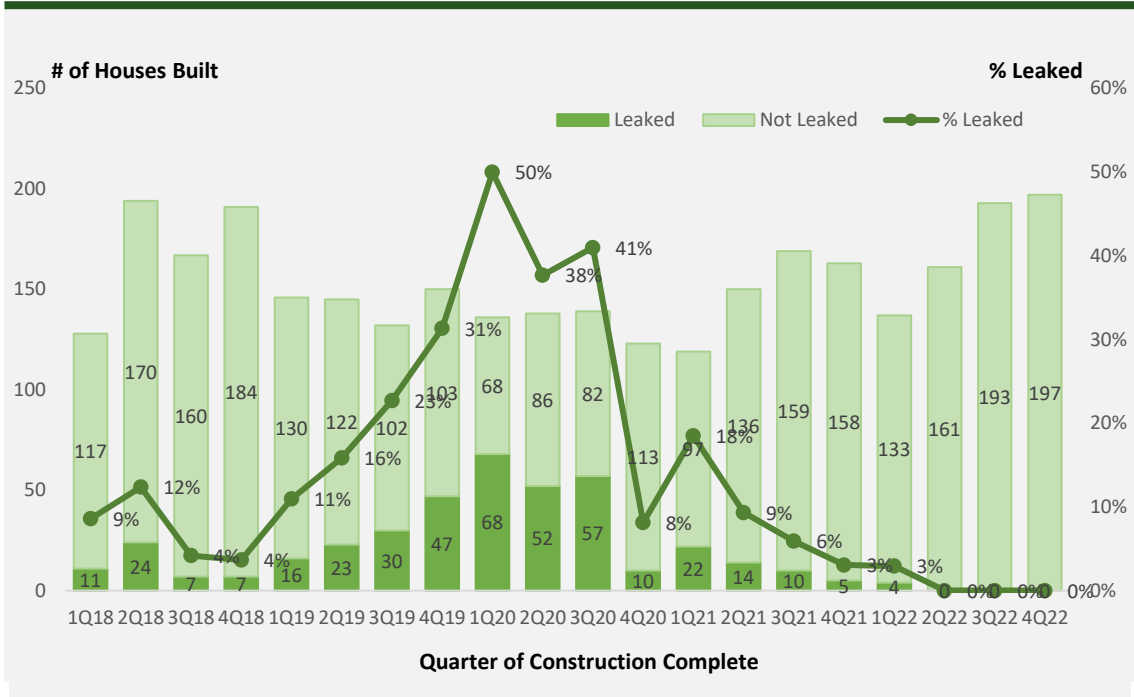
Leak rate by house build period

- Graph show which houses have leaked and not leaked by construction period
- House built between 4Q19 and 3Q20 have a much higher leak rate (financial years)
- Homes built prior to 4Q19 are leaking at a much lower rate and those that have not been affected have a low probability of leaking

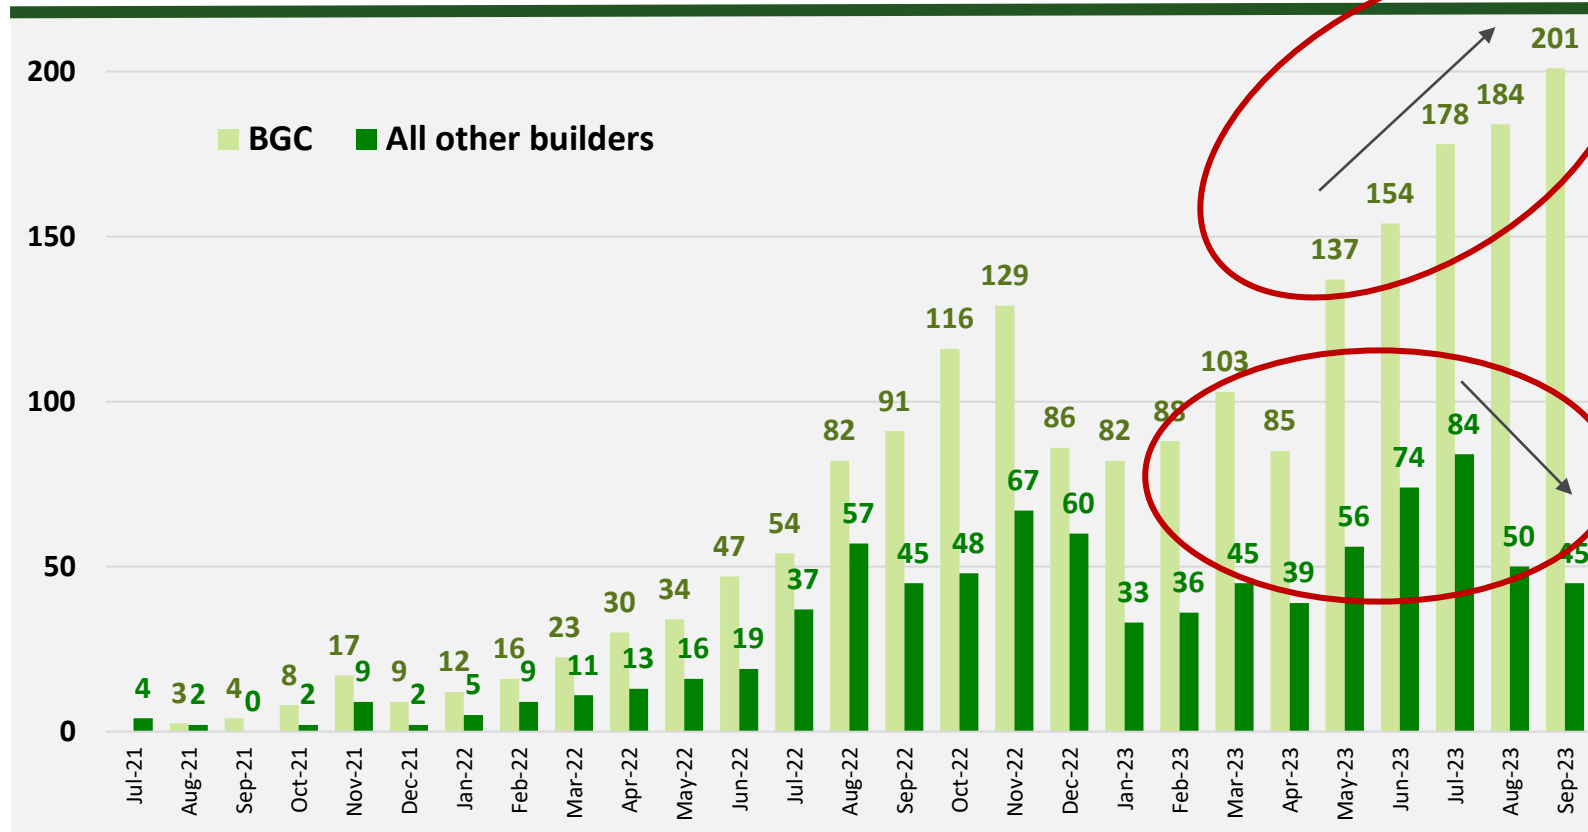
Plumbing failures (Jul 21 – Sep 23)

- BGC claims the situation is getting worse and we are only seeing the tip of the iceberg
- We are seeing the opposite trend with other builders who we are working with
- We have been proactively funding the replacement of ceiling pipes for 5 months now with Delstrat. BGC was provided the same offer, but declined.
- The builders we are working with have seen a ~46% reduction in leaks since July
